**AGENDA**  
**HISTORIC PRESERVATION BOARD MEETING**  
**September 5, 2024 at 4:00 PM**

- a. HPB Case 24-21: Application for Certificate of Appropriateness for demolition. Owner: Allen Sheffield; Address: 426 Kirby St., Palatka, FL 32177; Parcel #42-10-27-6850-0400-0021

Certification of Appropriateness Application for Complete Demolition of 426 Kirby Street, Palatka

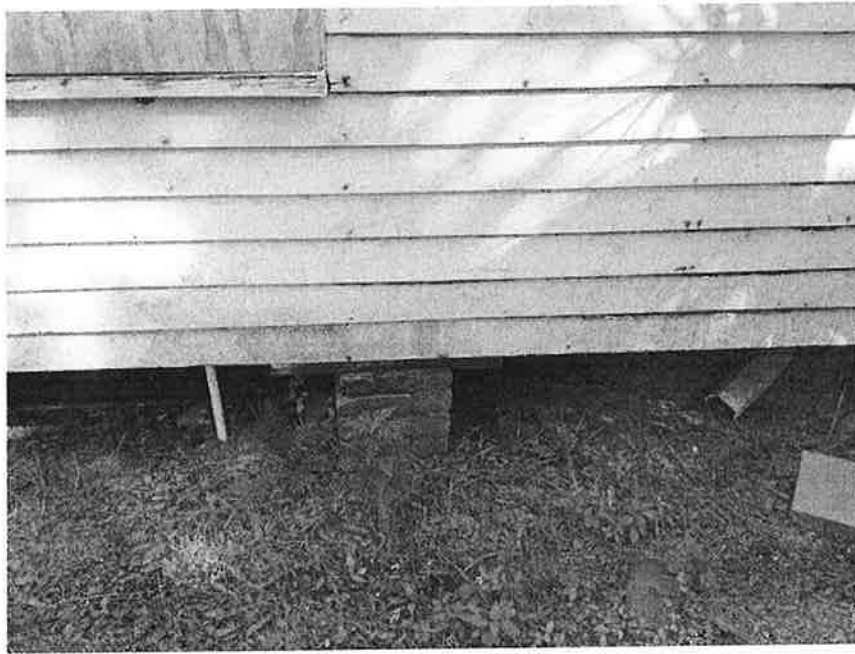
Pier: The photograph appears to show with added wood and loose blocks at top of brick pier

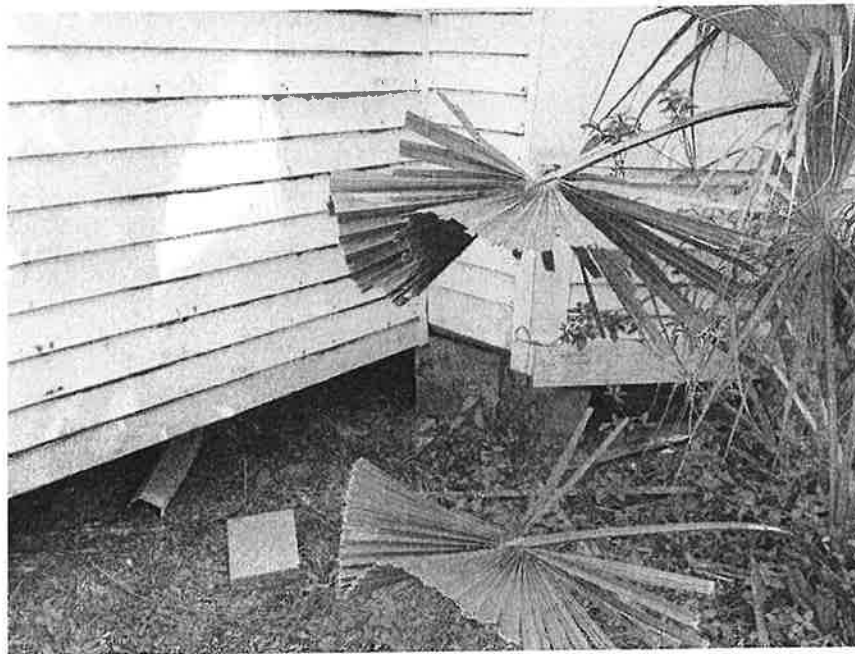
Pier Concrete block

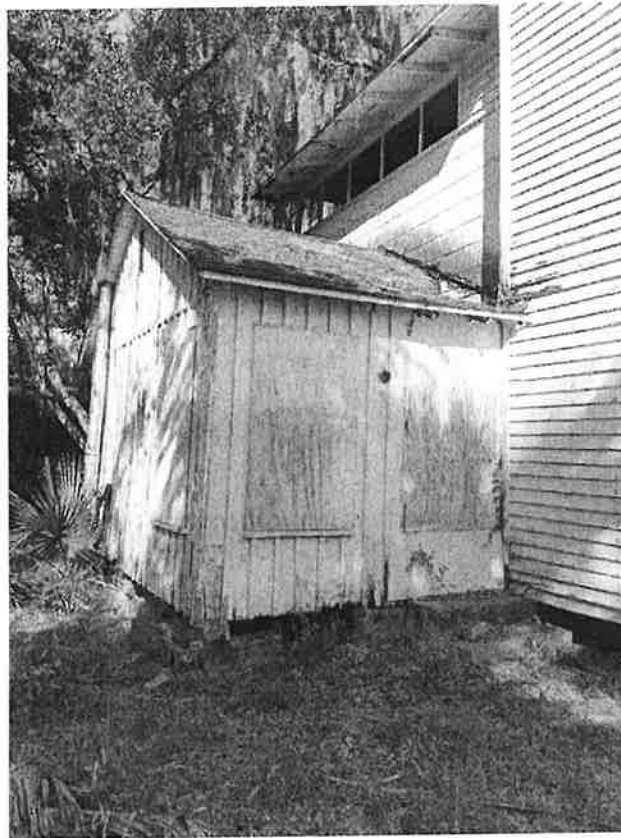
**Left-Rear (North-West) View of Possible Addition:** Roof Separation and patching.  
Deterioration of siding at bottom; Leaning pier with nearby loose blocks.

- One corner pier on the left (west) side of the house that supports the rear (north) room (or addition) appears rotated (leaning). This pier needs to be properly aligned and/or replaced. It may be necessary to install a footing below this pier.

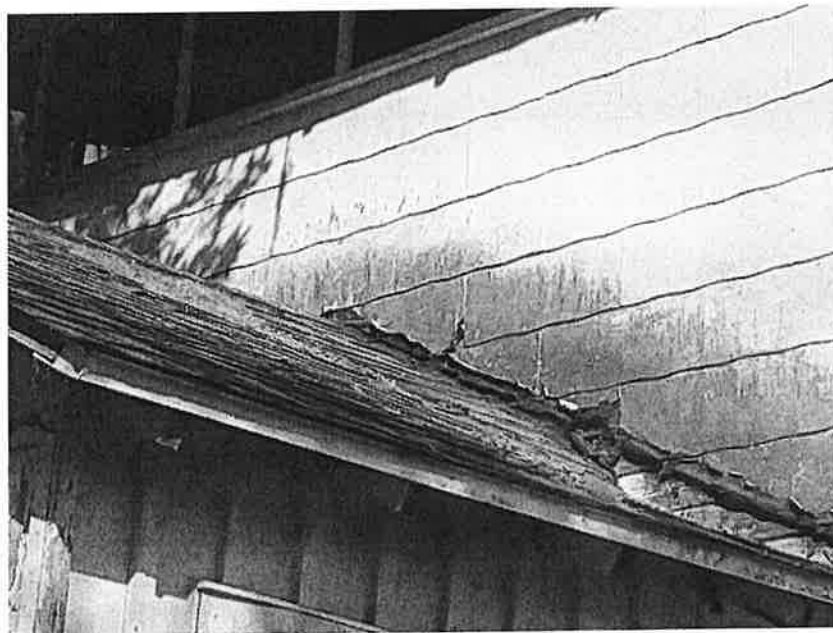
**Left-Rear (North-West) View of Possible Addition:** Roof Separation and patching.

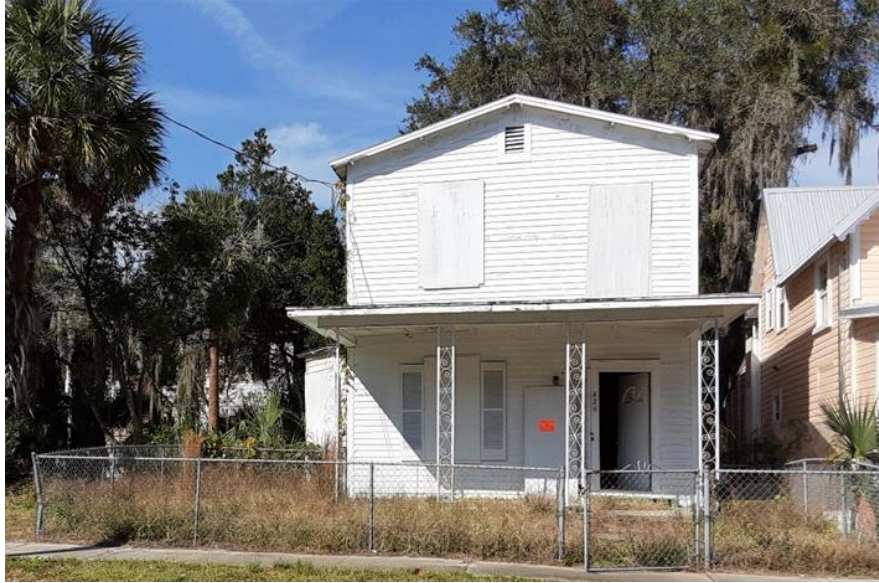
**Front (South) View:** Overgrown vegetation and relatively flat lot.

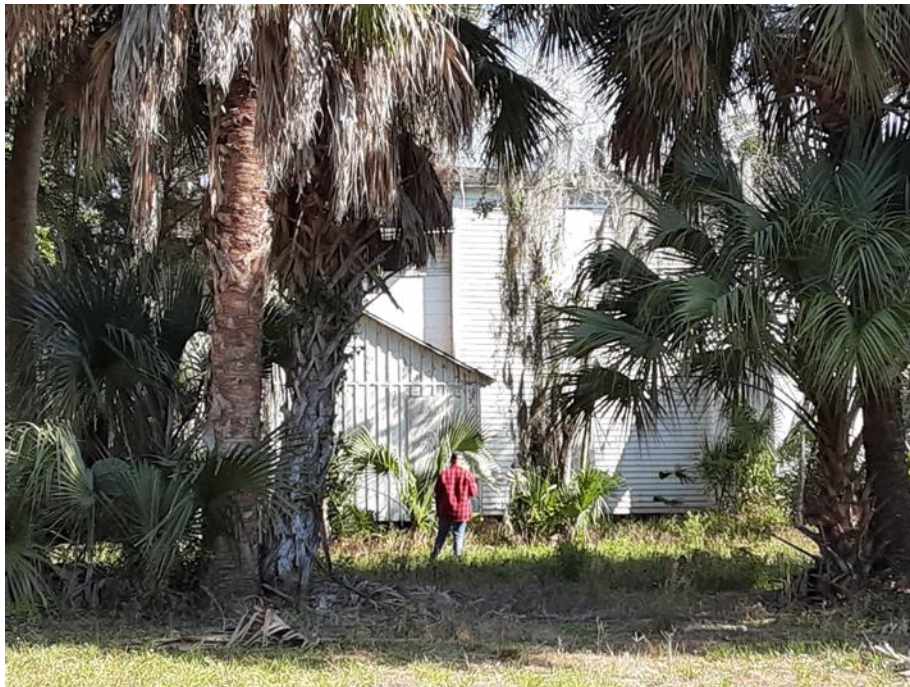
**Left (West) View:** Overgrown Vegetation and Relatively Flat lot.

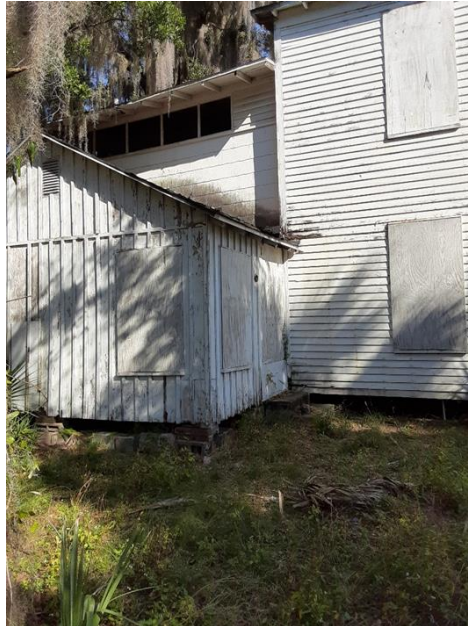
**Right (West) Side Near Rear:** Off grade Construction; Curvature in Upper Roof; Deteriorated outlookers; Vegetation near roof.

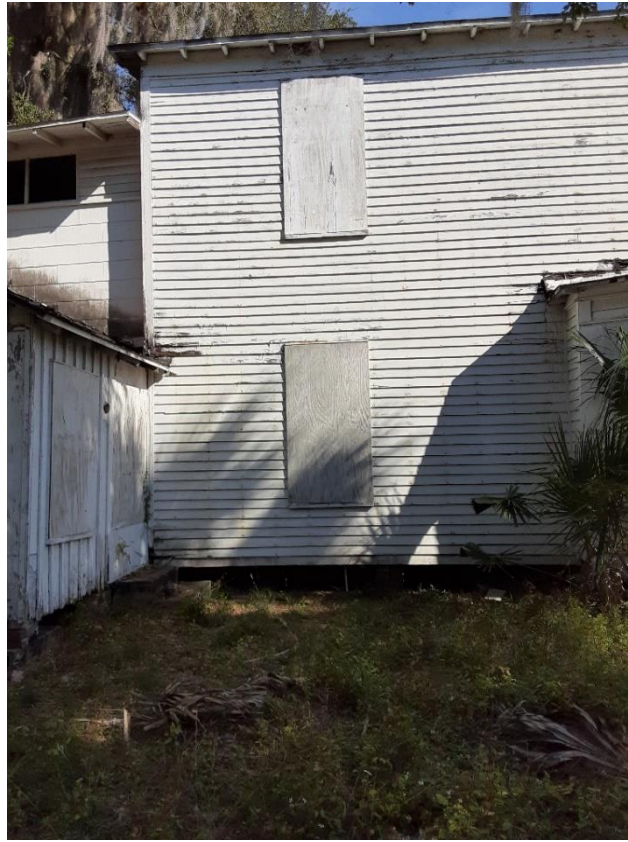
**Left (West) Side View:** Off grade construction; Relatively flat lot; Overgrown vegetation; Separation/Crack at roof intersection with side wall; Siding.

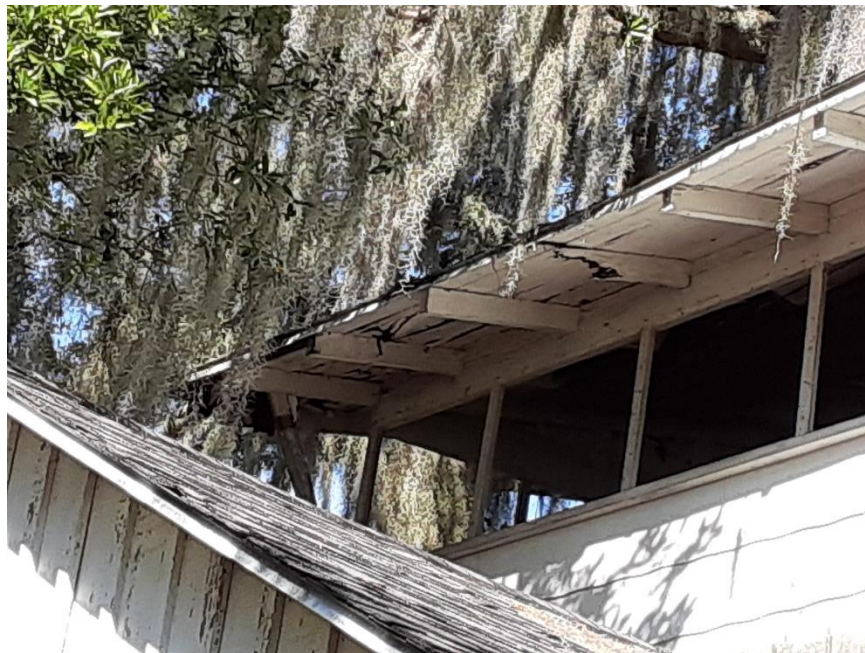
**Second floor Roof Overhang:** Damaged and deteriorated roof decking and outlookers

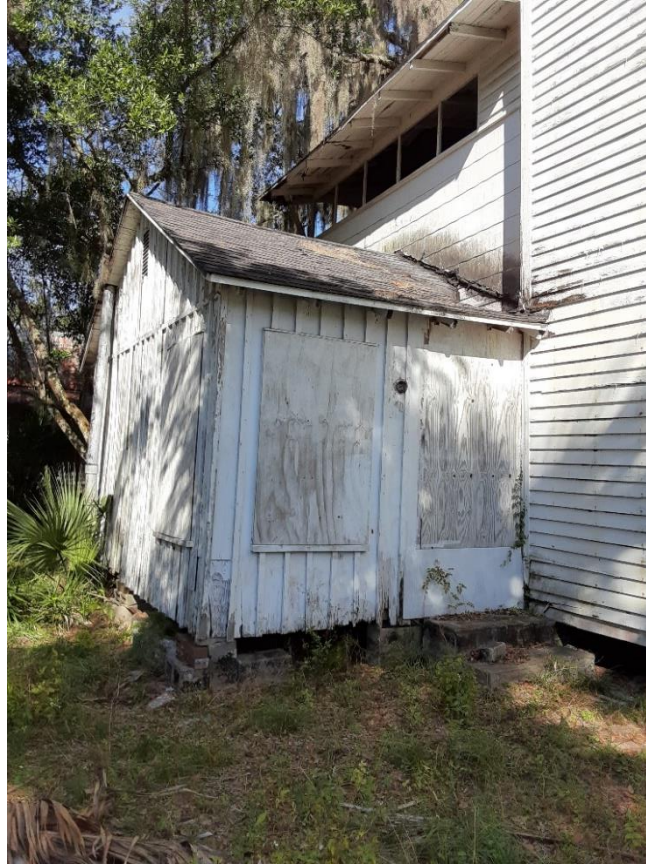
**Left-Rear (North-West) View of Possible Addition:** Roof Separation and patching.  
Deterioration of siding at bottom; Leaning pier with nearby loose blocks.

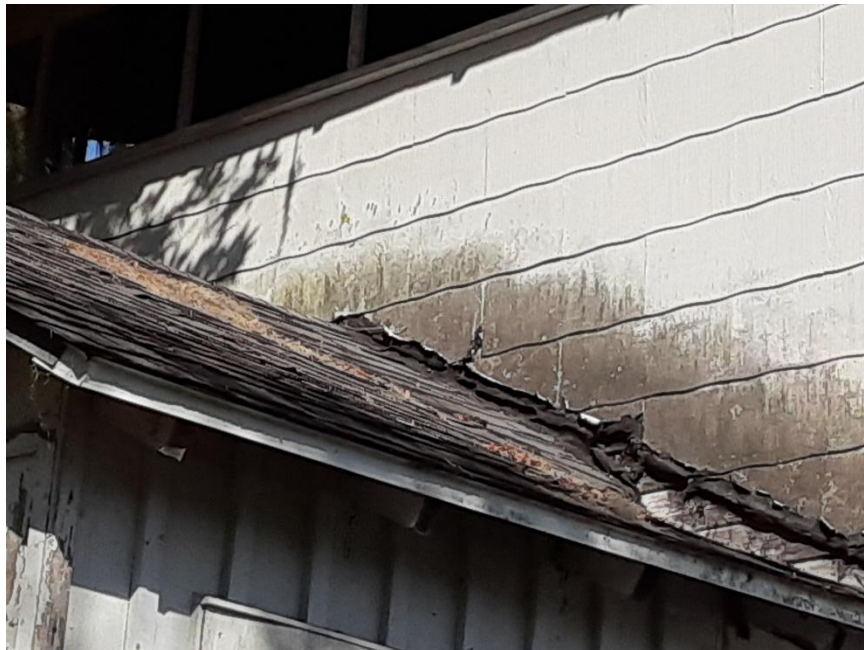
**Left-Rear (North-West) View of Possible Addition:** Roof Separation and patching.

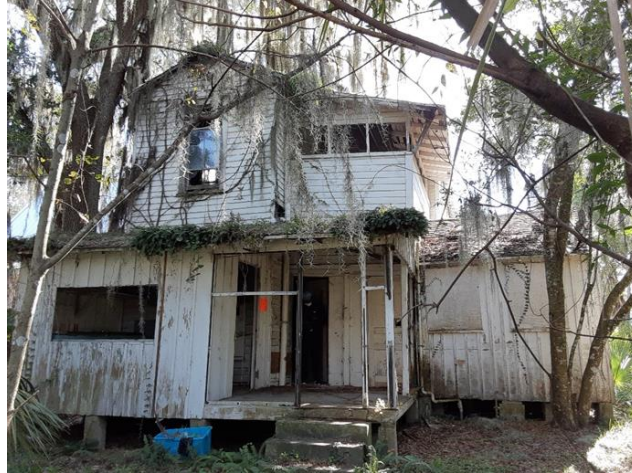
**Rear (North) View:** Overgrown vegetation close to structure and in contact with roof.

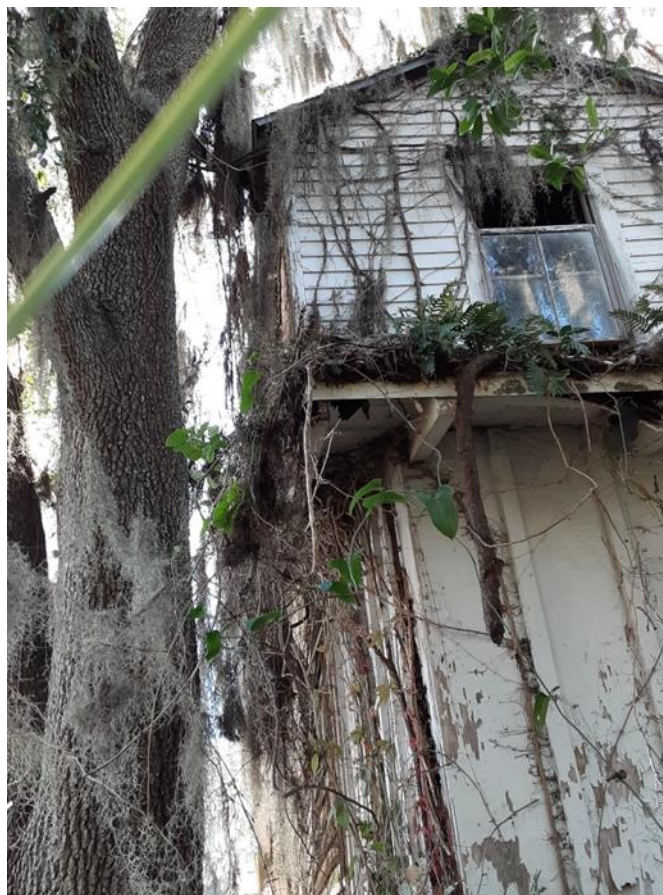
**Rear (North) View:** Overgrown vegetation close to structure and in contact with roof; Broken window; Rotted/Damaged soffit; Mildewed/Deteriorated/Peeling wood siding.

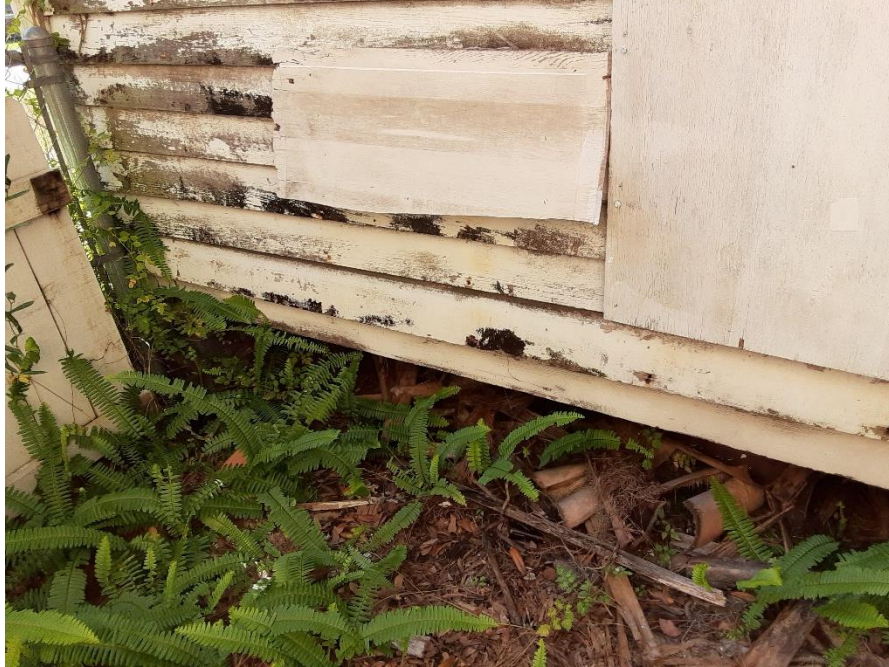
**Right-Front (South-East) Lower Corner:** Nearby vegetation; Mildewed Siding.

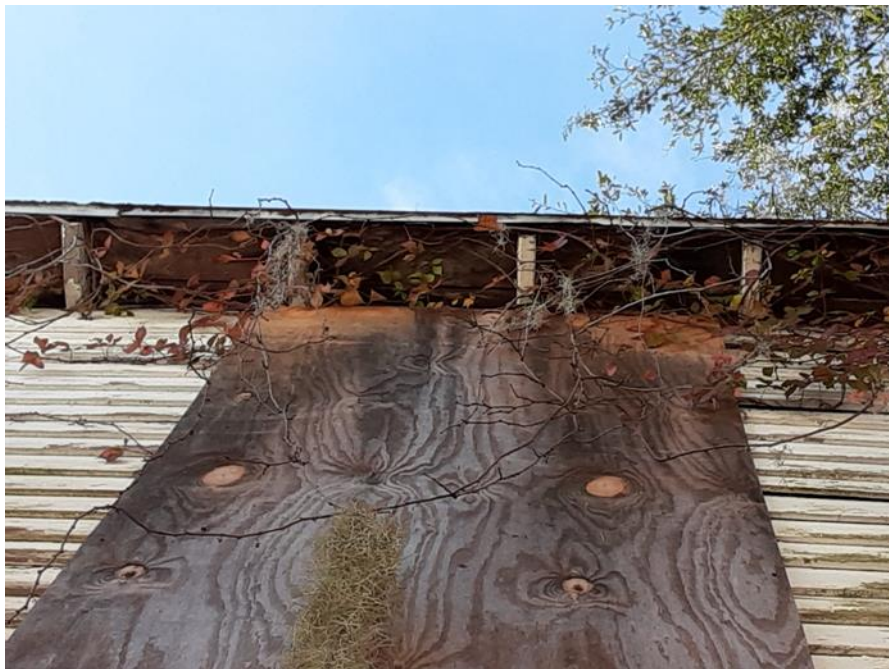
**Right (East) View:** vegetation growing on wall and along roof overhang area.

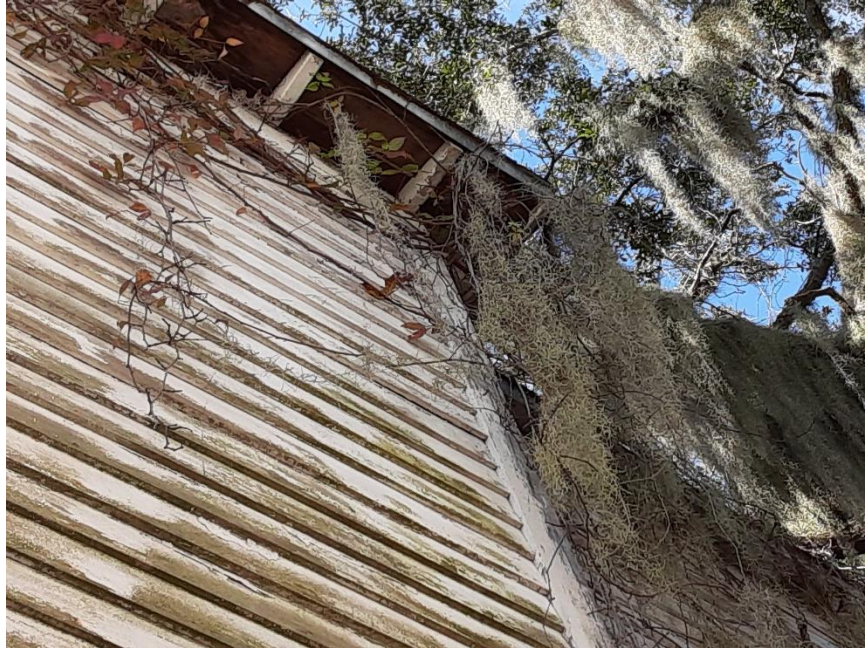
**Right (East) Wall and Roof Overhang:** Mildewed siding and growing vegetation.

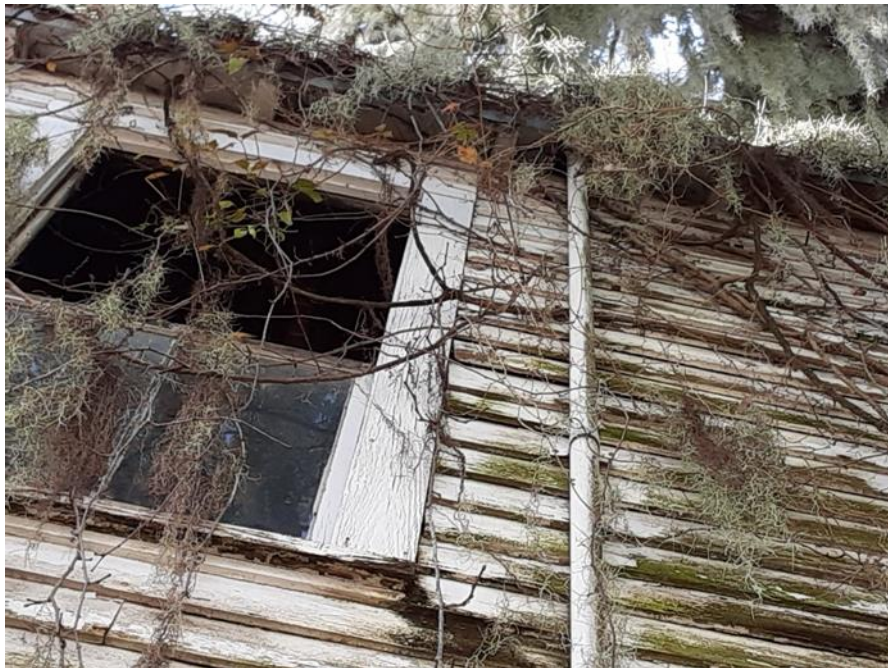
**Right (East) Wall and Roof Overhang:** Mildewed siding, vegetation, broken window and downspout.

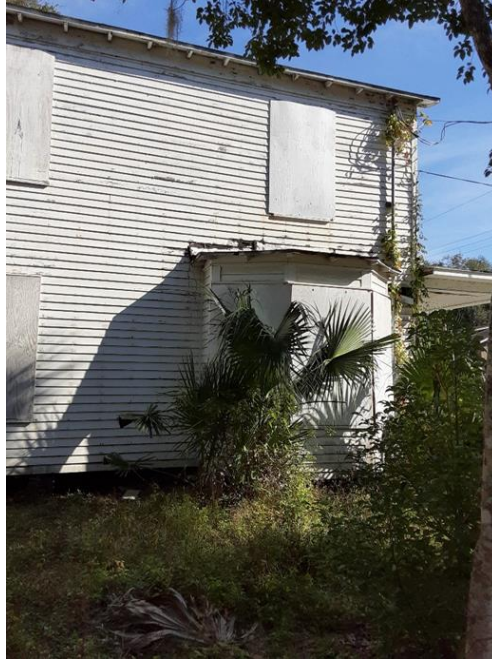
**Left (West) View near Front:** Vegetation near and in contact with house; Relatively flat lot; exterior walls in fairly good condition.

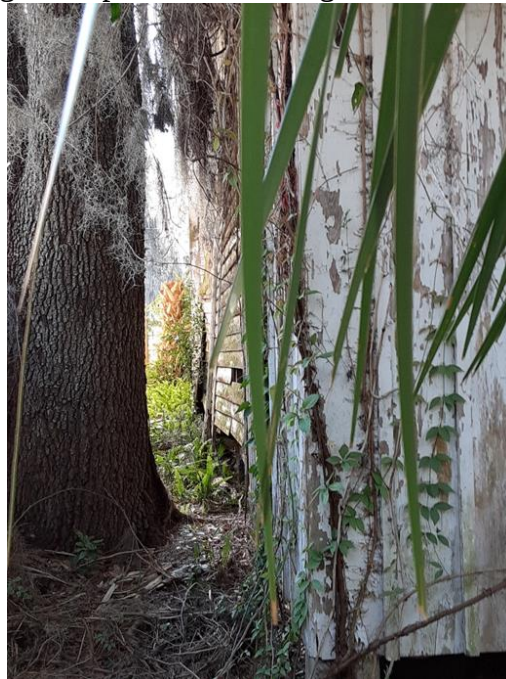
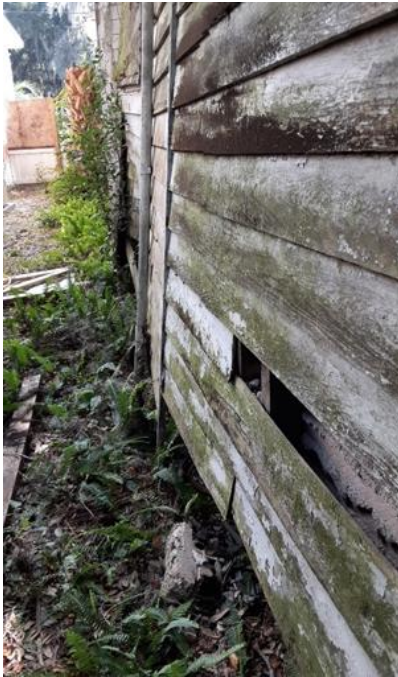
**Right (East) Wall Siding:** Damaged and Missing siding.

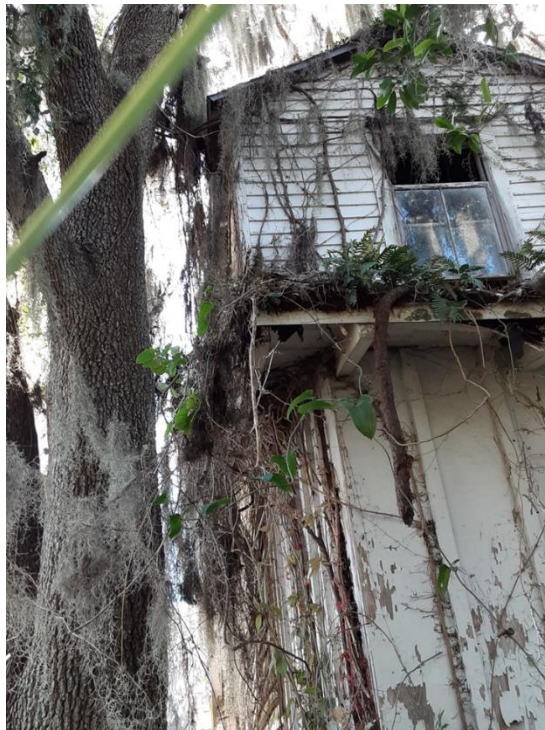
**Rear and Right Side:** Vegetation impacting structure; damaged siding; deteriorated roof edge and overhang; broken window.

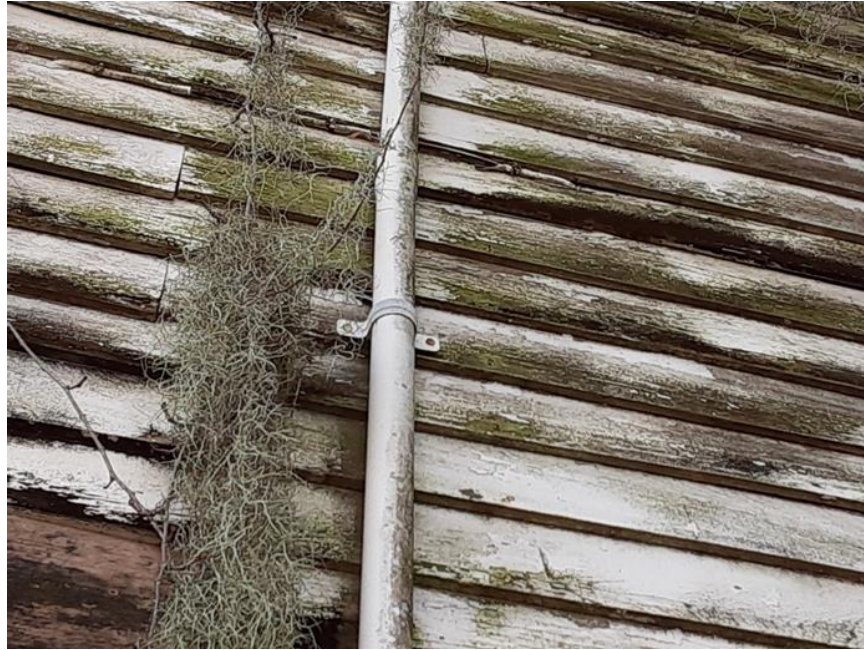
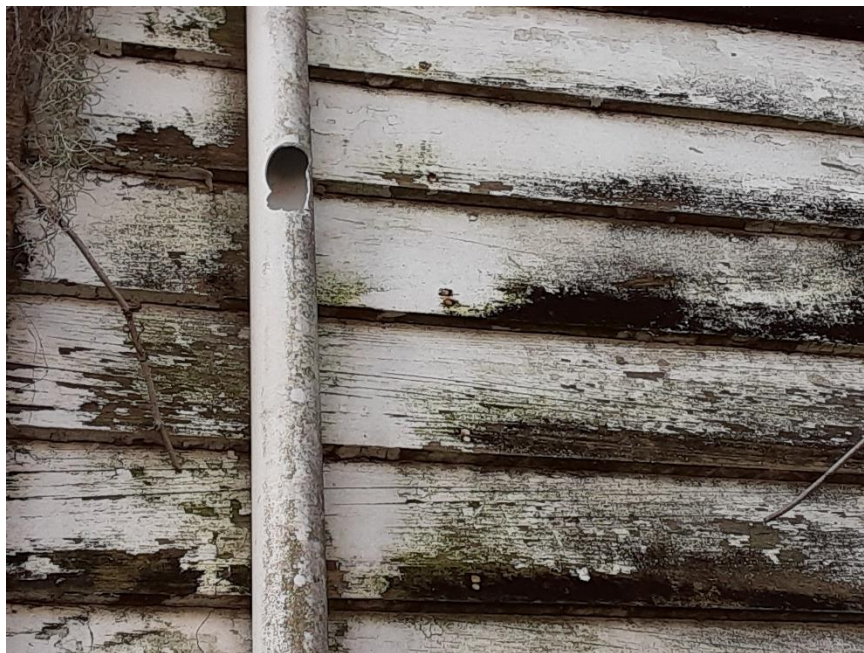
**Right (East) Side Wall: Downspout, damaged and mildewed siding.**

On the left side of the house, what appeared to be a downspout was broken. While the top of the roof was not visible from the ground, due to the age of the house and the amount of repairs that will be needed, the roof will most likely need to be replaced. When that happens, new roof vents, gutters and downspouts can be installed.

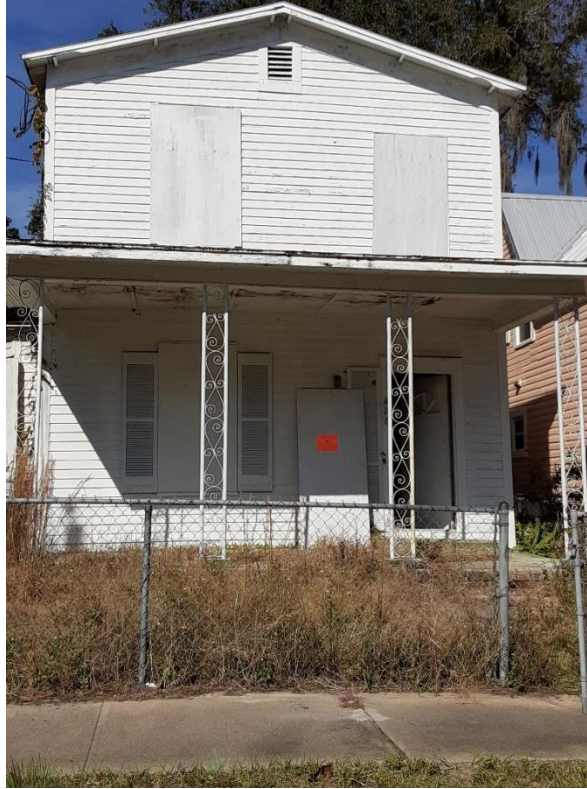
**Front (South) View:** Showing stained/damaged/deteriorated wood soffit (ceiling) on the front porch.

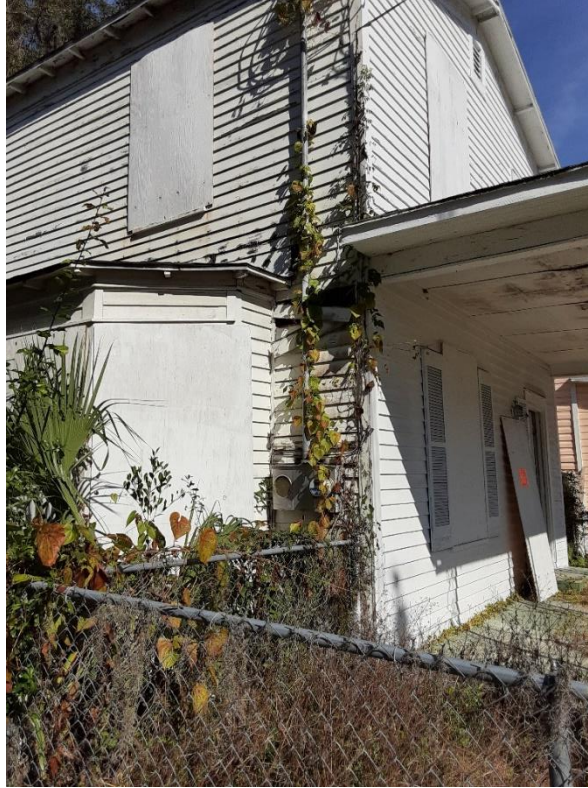
**Left Front (West-South) Corner:** Vegetation damaging siding and growing on the front porch; damaged porch ceiling possible from room leakage in past, electric meter box locations visible.

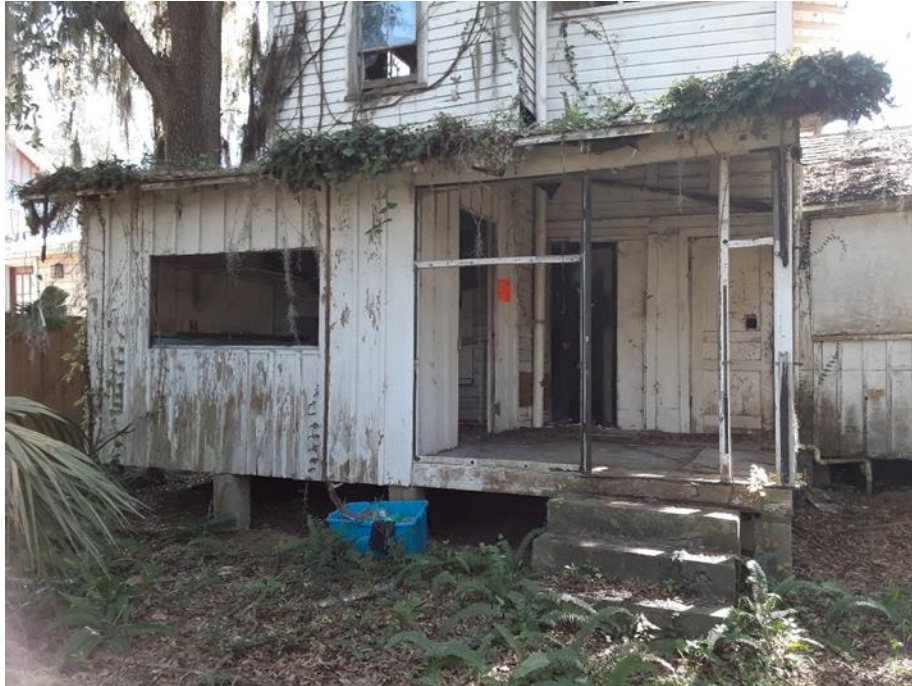
**Rear (North) View:** Rear porch and side room with vegetation on the roof and walls; crack in rear step.

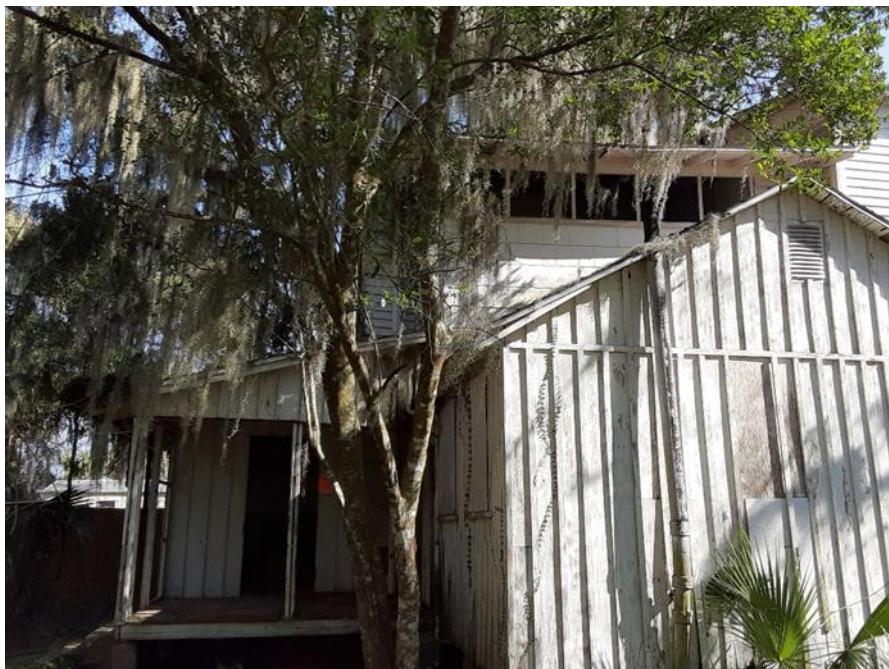
**Rear Porch viewed from Left (west) side:** The rear porch appears to be distorted (as if leaning toward the house). Perhaps, the orientation of the camera contributes to this slant. However, the rear porch is in very bad condition and needs to be demolished. A tree and other vegetation is growing very close to the structure.

The rear porch was constructed of wood. This wood porch was badly deteriorated and needs to be removed and replaced. The joist/beam support below the porch was broken and displaced. The wood decking was deteriorated and had holes. Some roof rafters over the rear porch were broken and/or sagging.

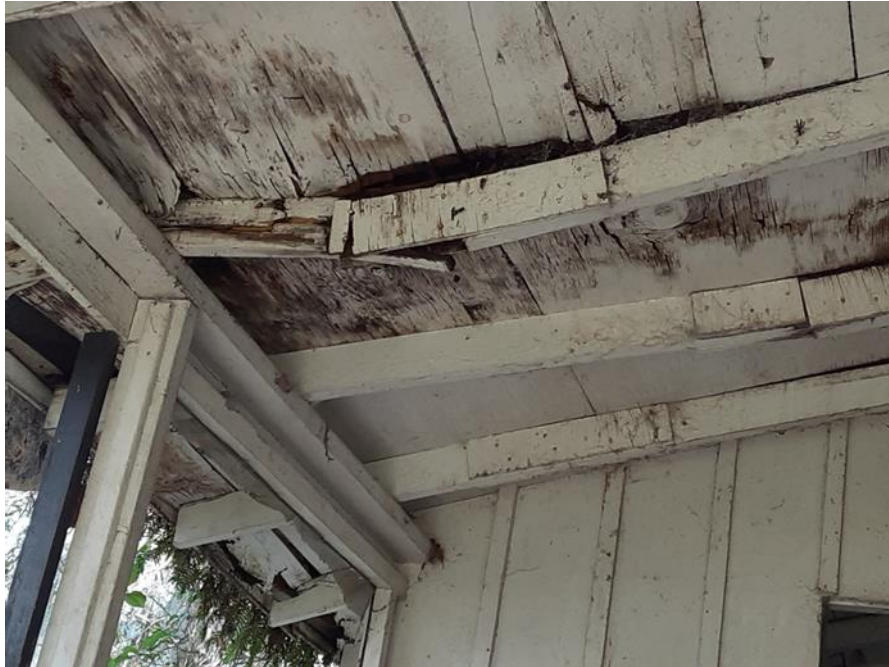
**Rear Porch:** Spliced and Broken Rafter; Deteriorated/broken soffit; Rotted outlookers (roof overhang supports).

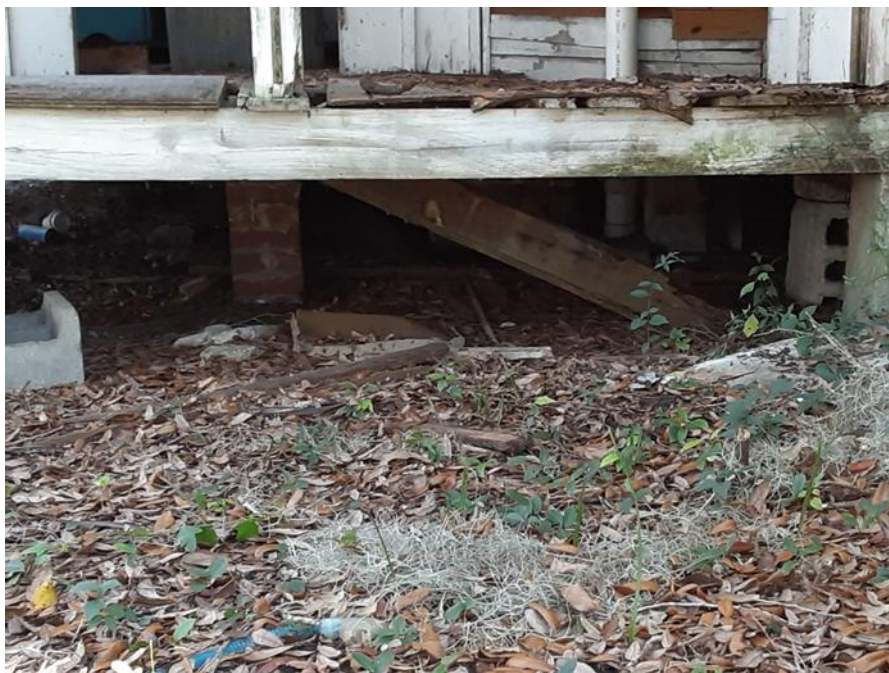
**Rear Porch:** Broken joist in contact with the ground; brick pier; block support without mortar and oriented with open cell horizontal; deteriorated and missing porch floor.

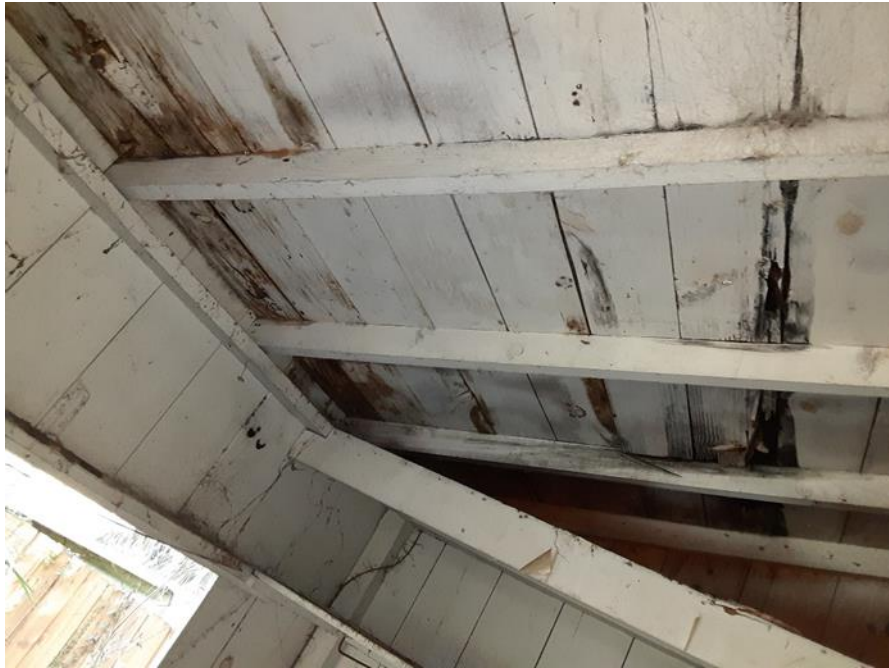
**Rear Porch Rafters and Roof Sheathing:** Roof sheathing was damaged and showed signs of past leakage (water stains) on the rear porch and in the small room adjacent to the rear porch. Damaged spliced and broken rafters existed on the rear porch

**Rear Room Adjacent to Rear Porch:** Roof sheathing damaged and showing signs of past leakage (water stains).

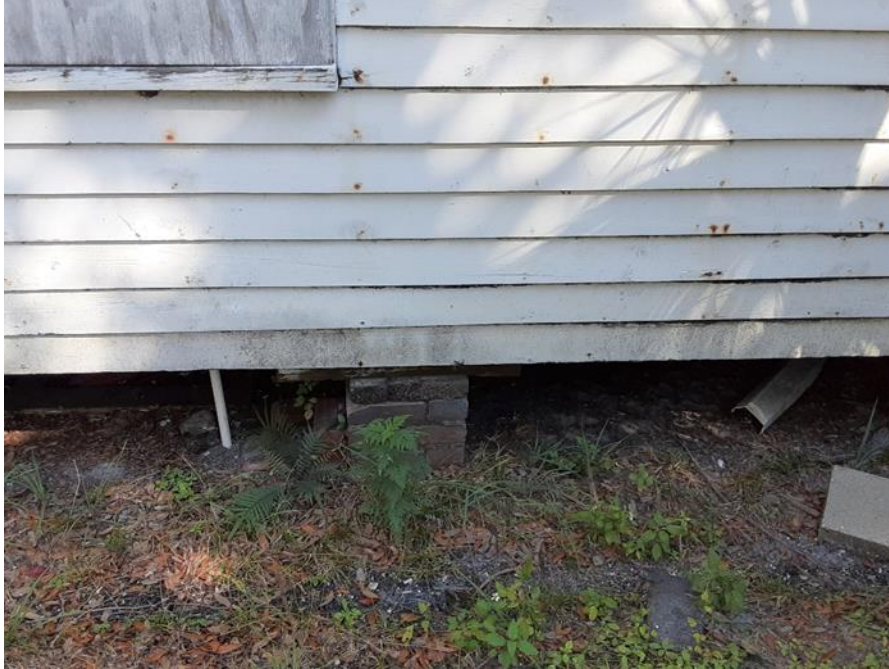
Pier: The photograph appears to show with added wood and loose blocks at top of brick pier

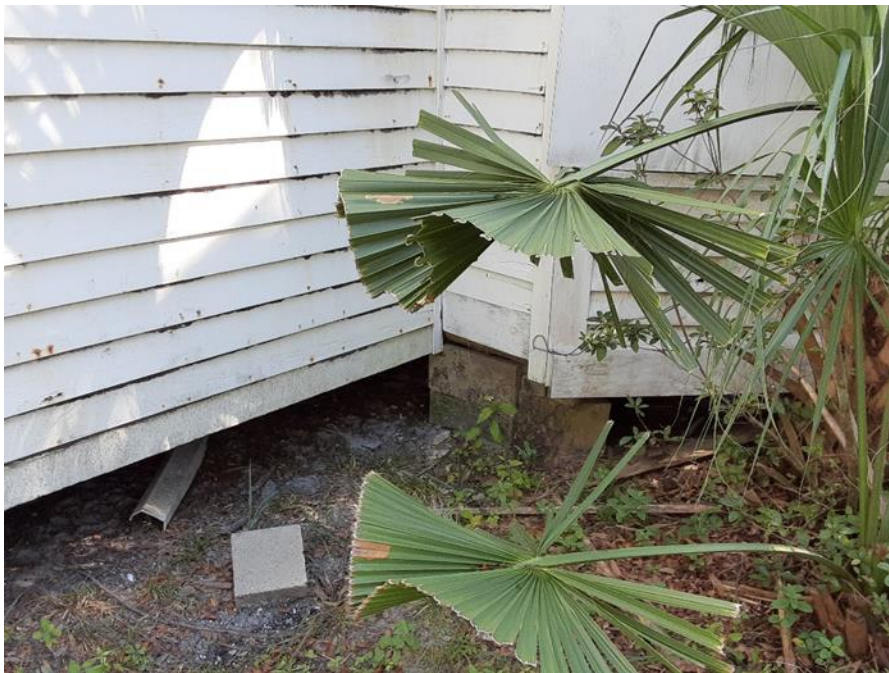
Pier Concrete block

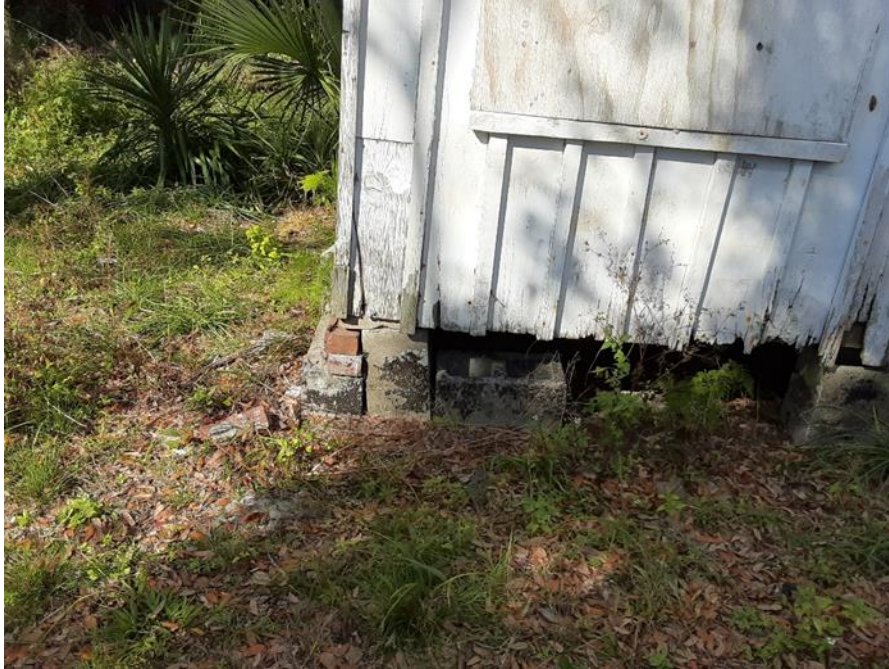
Pier: Leaning and Propped Concrete block

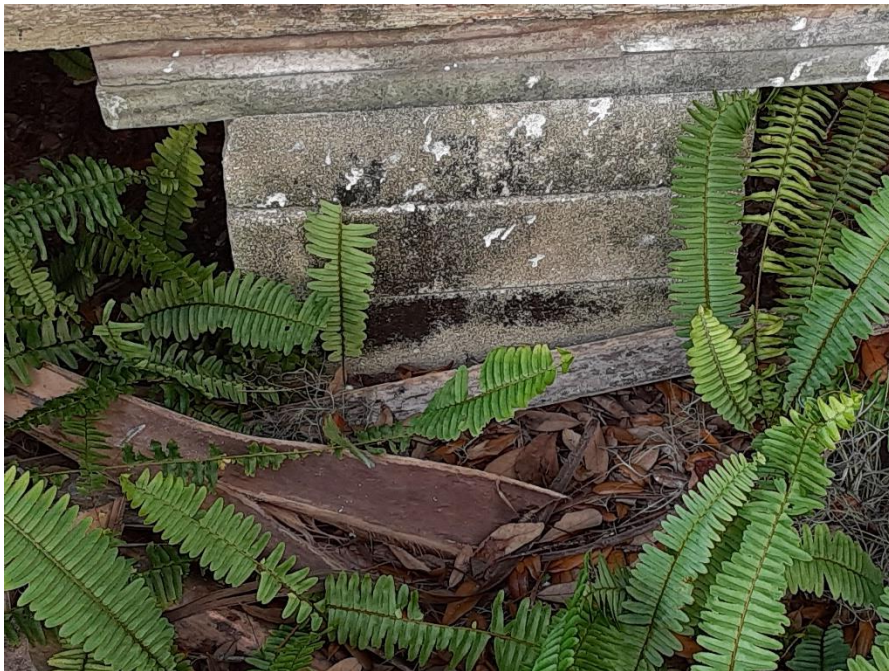
Pier: Concrete block

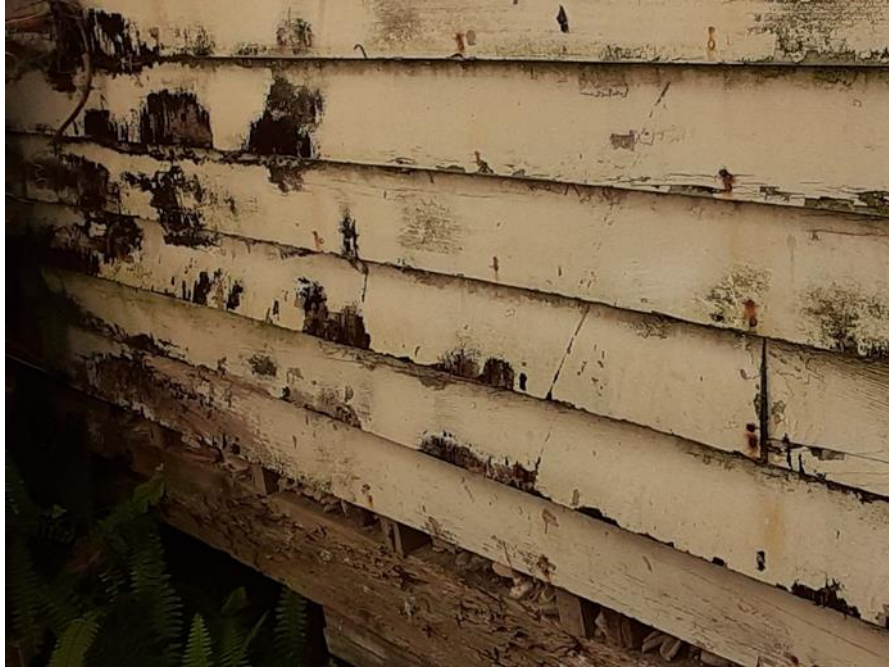
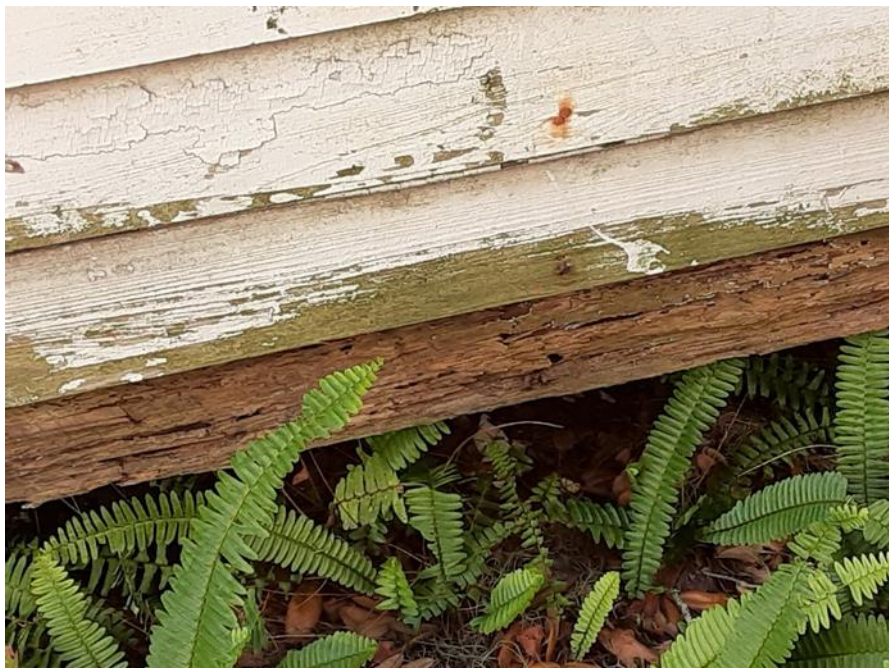
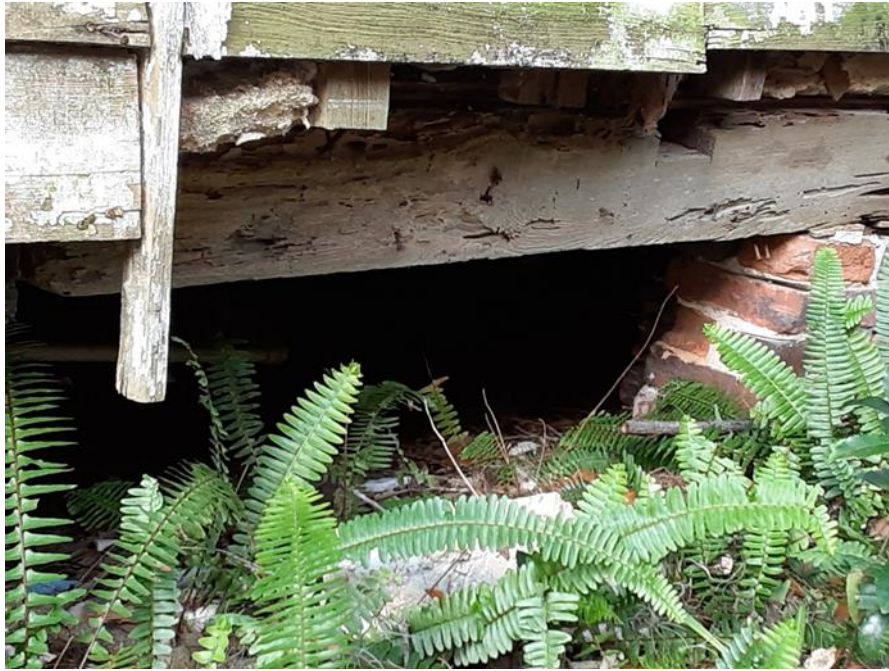
**Right (East) Sill Beam:** Deteriorated/Rotted/WDO damaged sill beam;

**Right (East) Sill Beam:** Deteriorated/Rotted/WDO damaged sill beam.

- The exposed sections of sill beam on the right side of the house that appears to be deteriorated should be replaced.
- Even the deteriorated sill beam still provides enough support for the floor system that from the exterior, the elevation of the floor system does not appear to be greatly displaced.

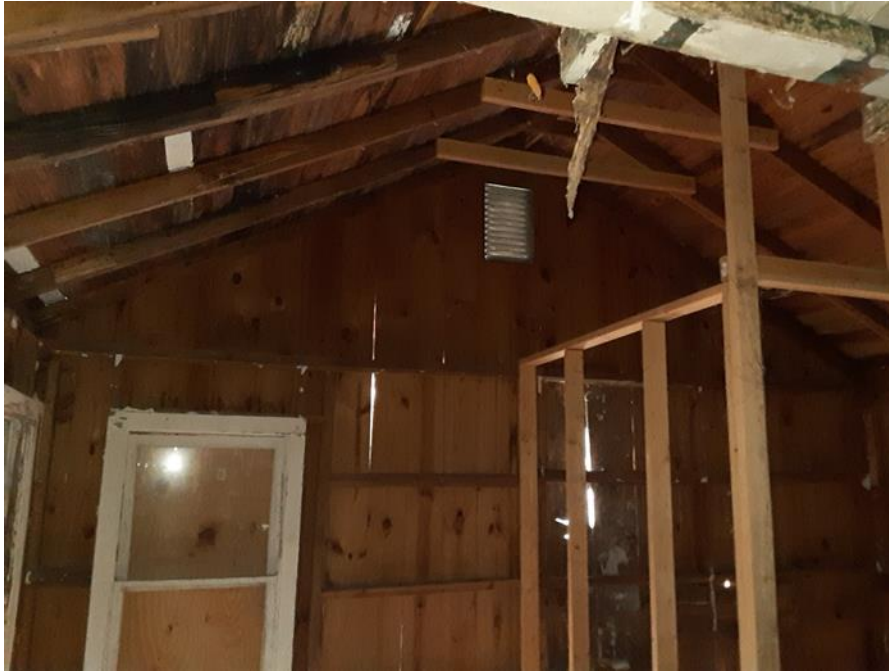
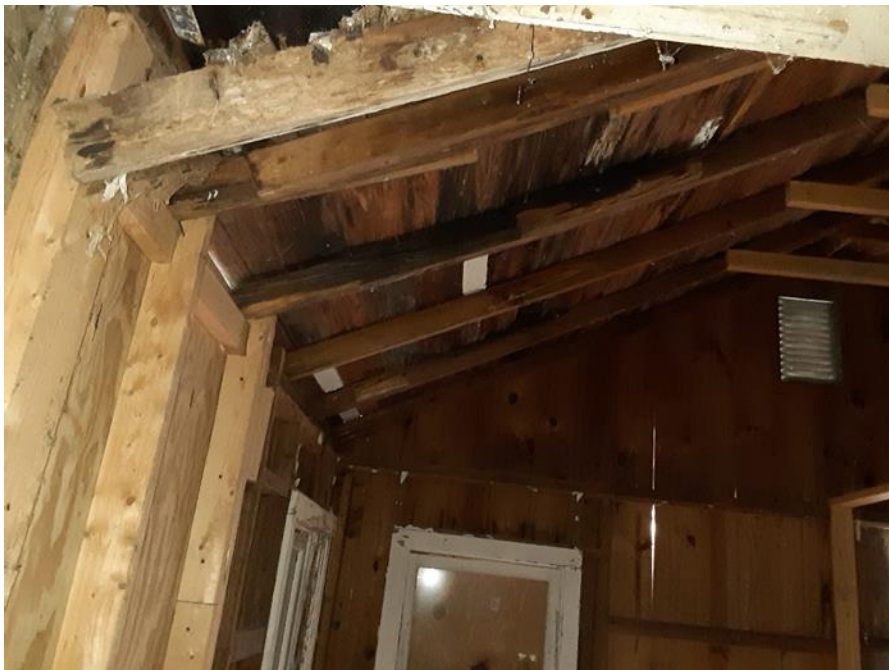
**Left Rear (West-North) Room:** New collar ties and wall construction; damaged and sliced rafters; water stains and holes in roof decking.

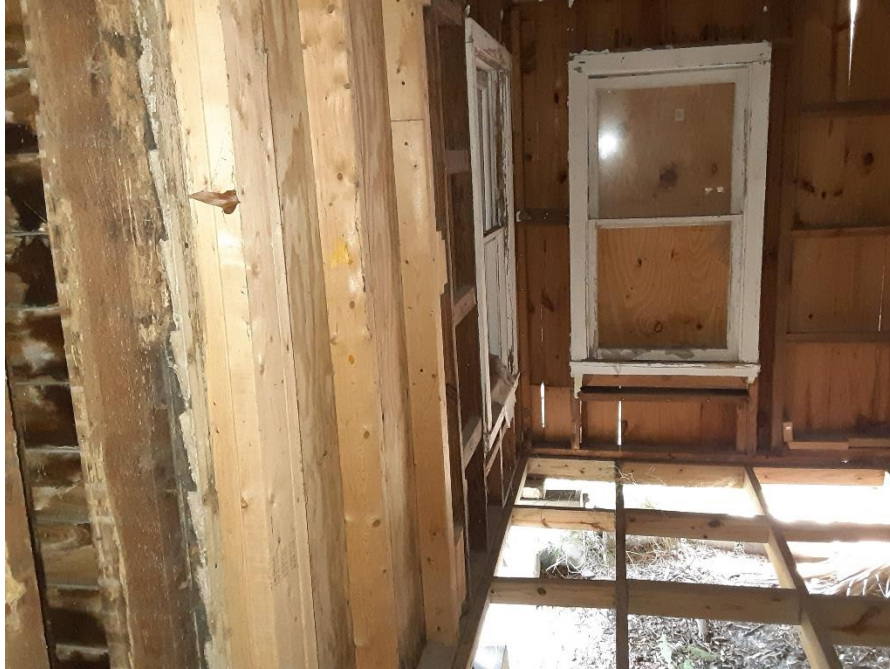
**Left Rear (West-North) Room: Incomplete Wall and Floor Repair**
