**AGENDA**  
**HISTORIC PRESERVATION BOARD MEETING**  
**September 5, 2024 at 4:00 PM**

- a. HPB Case 24-21: Application for Certificate of Appropriateness for demolition. Owner: Allen Sheffield; Address: 426 Kirby St., Palatka, FL 32177; Parcel #42-10-27-6850-0400-0021

Certification of Appropriateness Application for Complete Demolition of 426 Kirby Street, Palatka

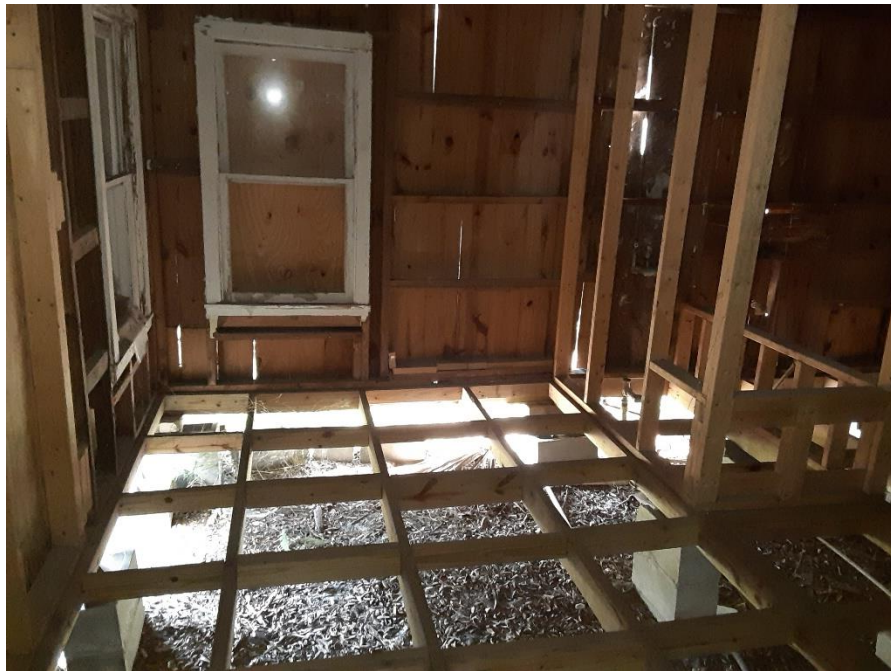
**Left Rear (West-North) Room: Wall and Floor Repair**

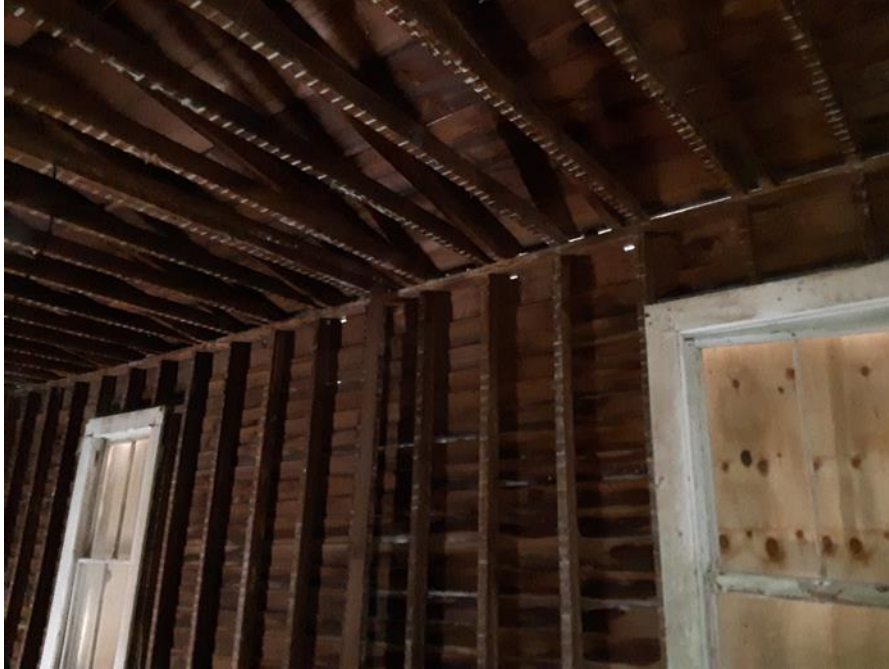
**Second Floor Roof Rafters, Roof Joist and Wall Studs:** These appear to be in very good condition; Actual 2" dimensioned lumber; some wood staining on roof decking and wall siding. The roof slope was not measured but was relatively low.

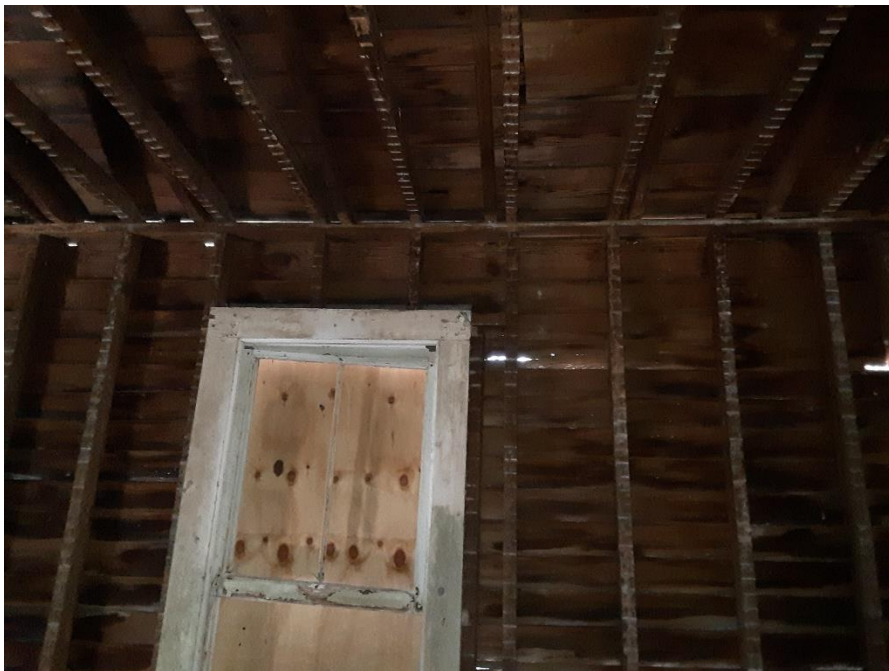
**Second Floor Roof Sheathing, Rafters, Roof Joist and Wall Studs:** Staining of roof and wall members.

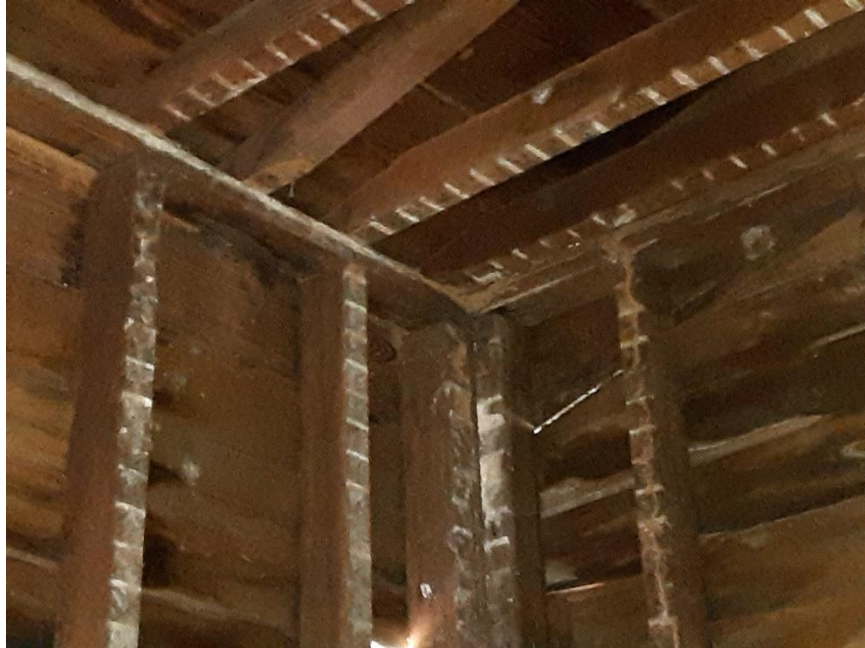
**Second Floor Roof and Wall Corner Framing:** The picture does not show a double top plate; No hurricane clips or other metal connectors are present.

- Metal connectors are needed to strengthen the overall structure and to provide connectivity from the foundation system to the roof system as required by the Florida Building Code. Metal connectors (i.e., hurricane clips, anchor bolts, stud connectors, foundation straps) were not observed during the inspection. These connectors need to be added during construction.

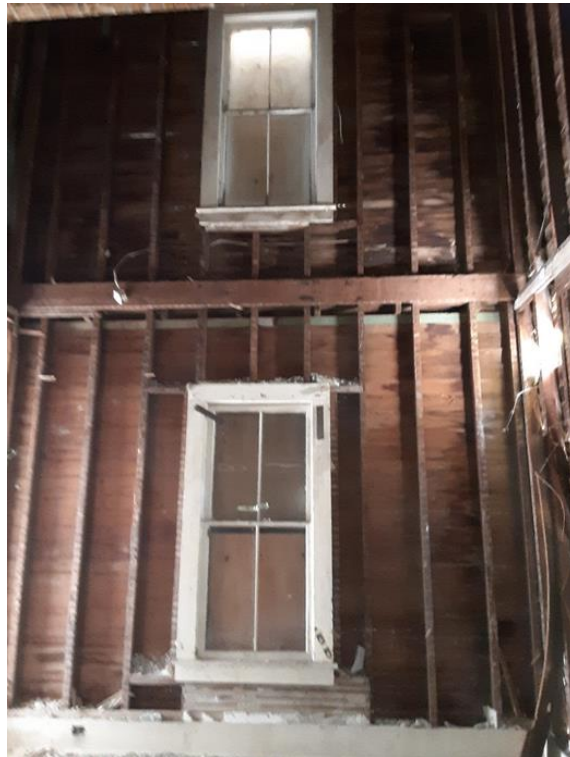
**Exterior Wall Framing:** Balloon Framing; Structural Members in good condition; some darkened/stained siding.

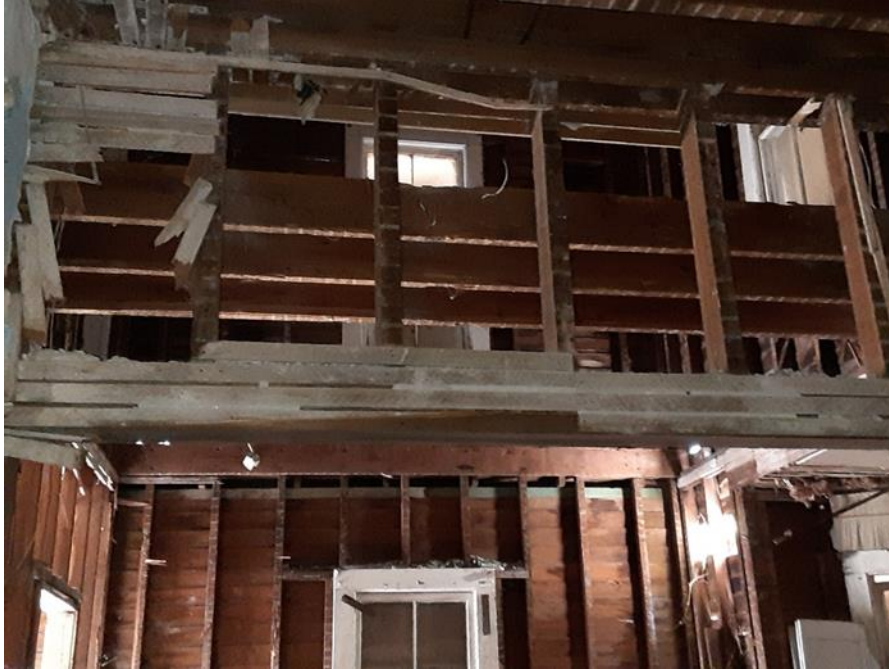
**First and Second Floor Wood Framing:** The exposed members appear to be in good condition.

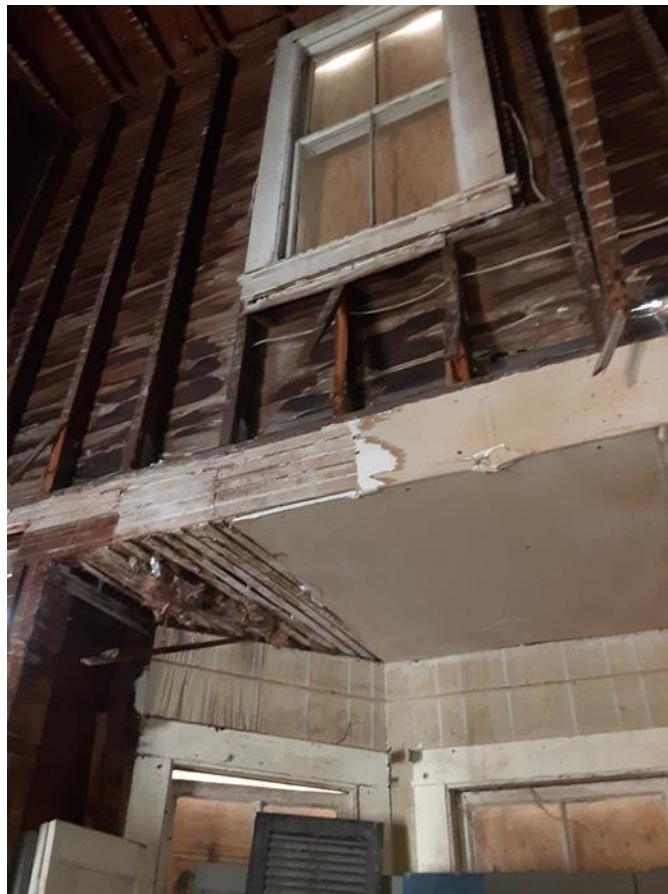
**Exterior Wall: Walls and Window framing:** very good condition of the studs and some other structural members; damage shown may have resulted from demolition activities.

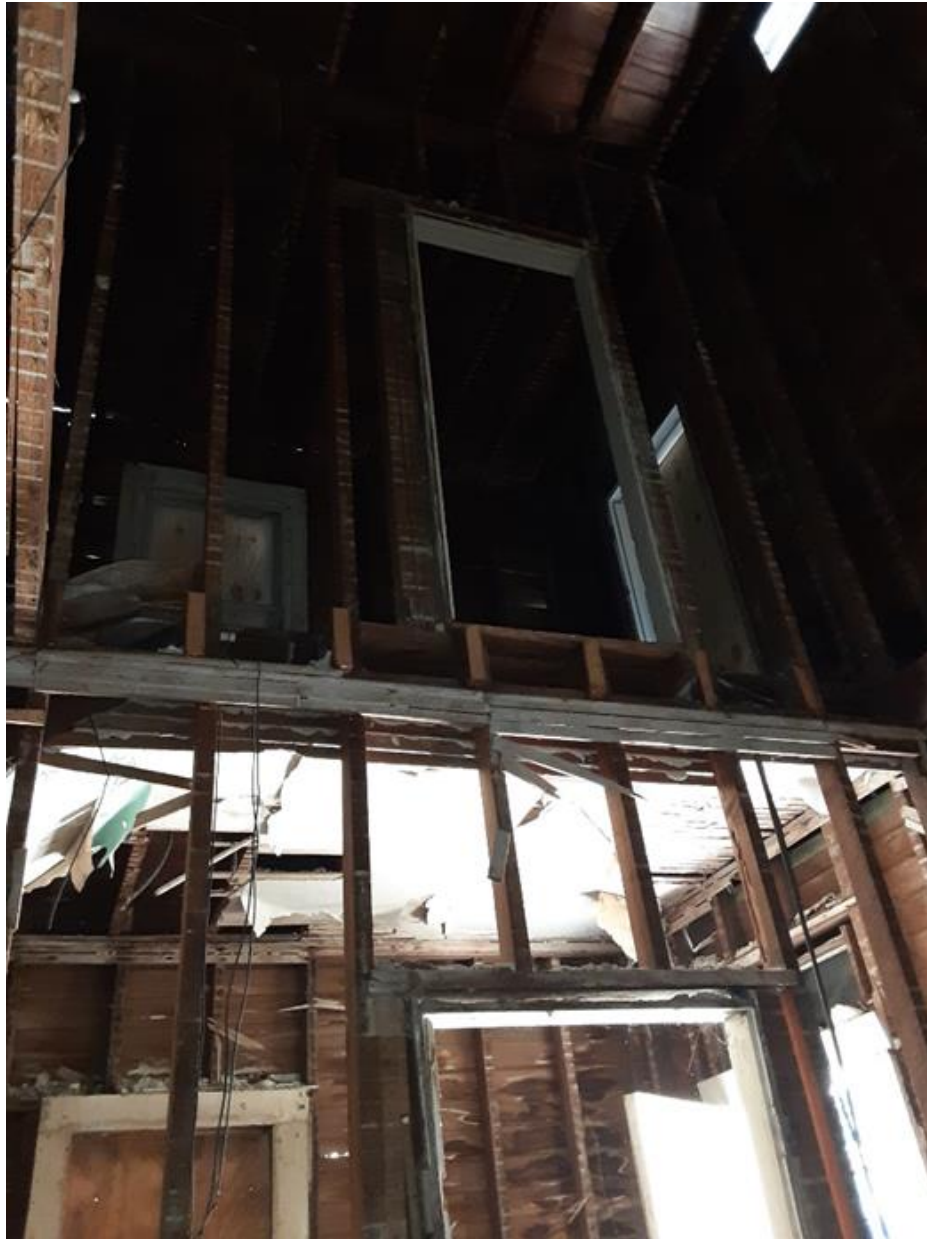
**Interior Wall Framing:** View from Down Stairs Looking to Upstairs; studs in good condition, cut and removed ceiling/floor joists supporting second floor.

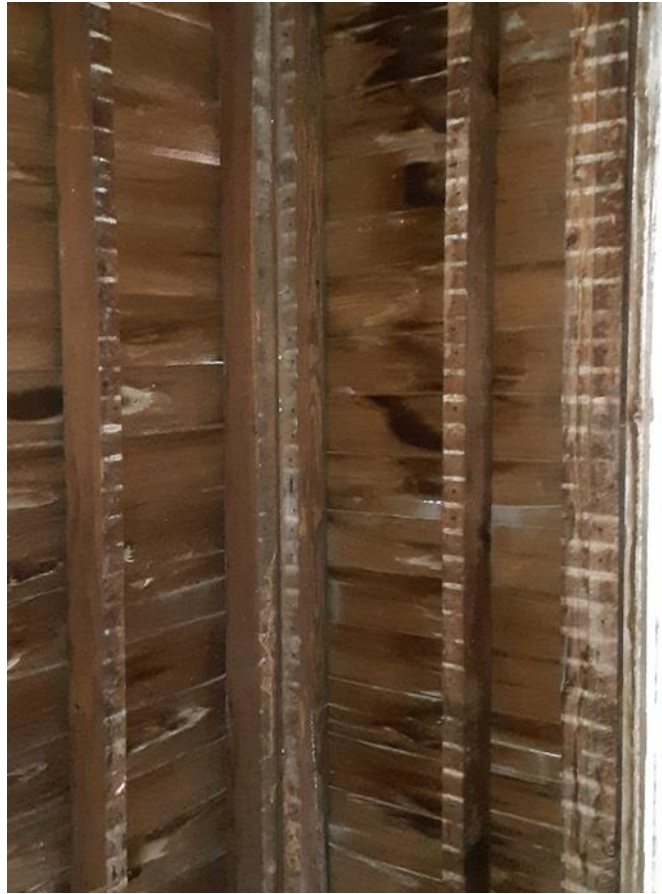
**Corner Framing:** Studs in good condition; 2x4 actual size studs.

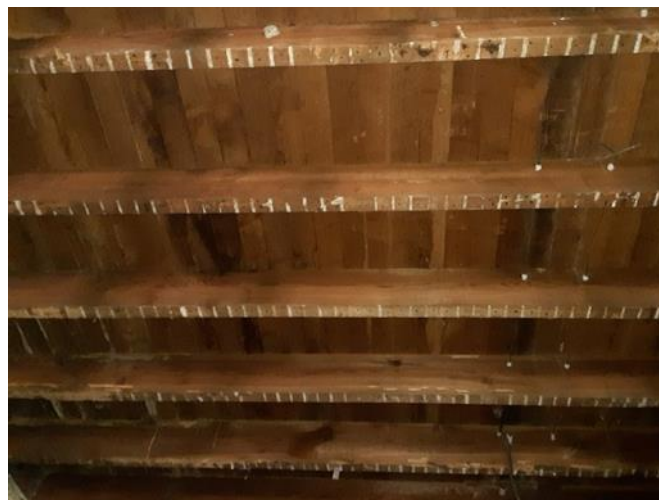
**Ceiling/Floor Joist and Subfloor for Second Floor:** Structural Members in Very good Condition.

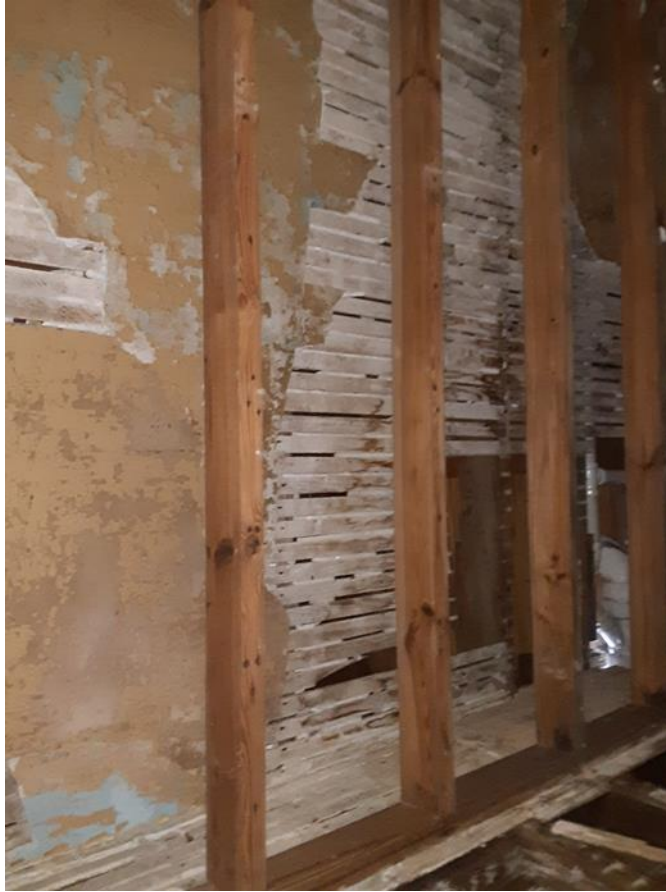
**Interior Wall:** Studs in very good condition.

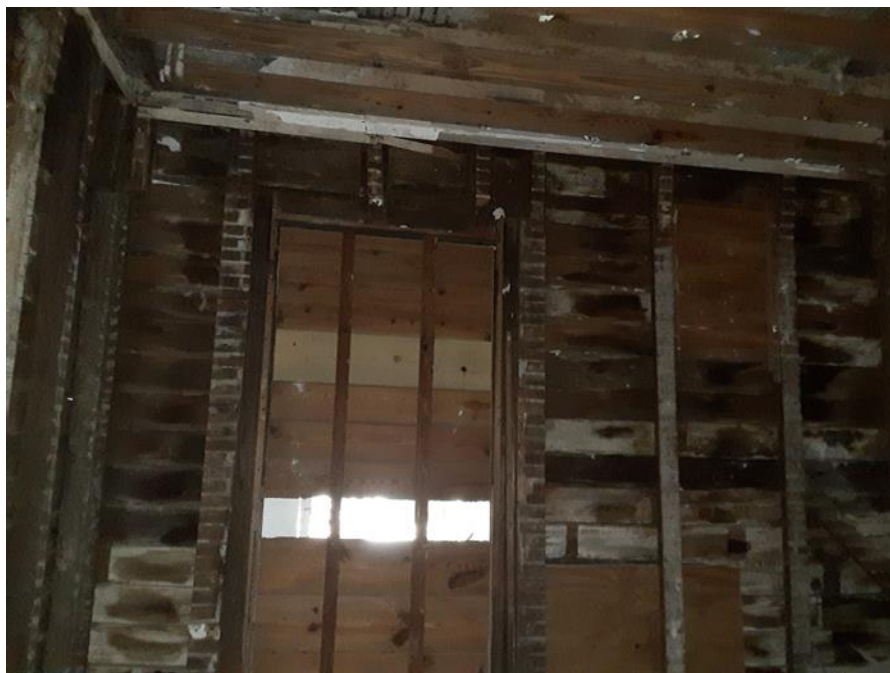
**Exterior Wall Right (East) Side:** Missing Siding and Discolored Siding.

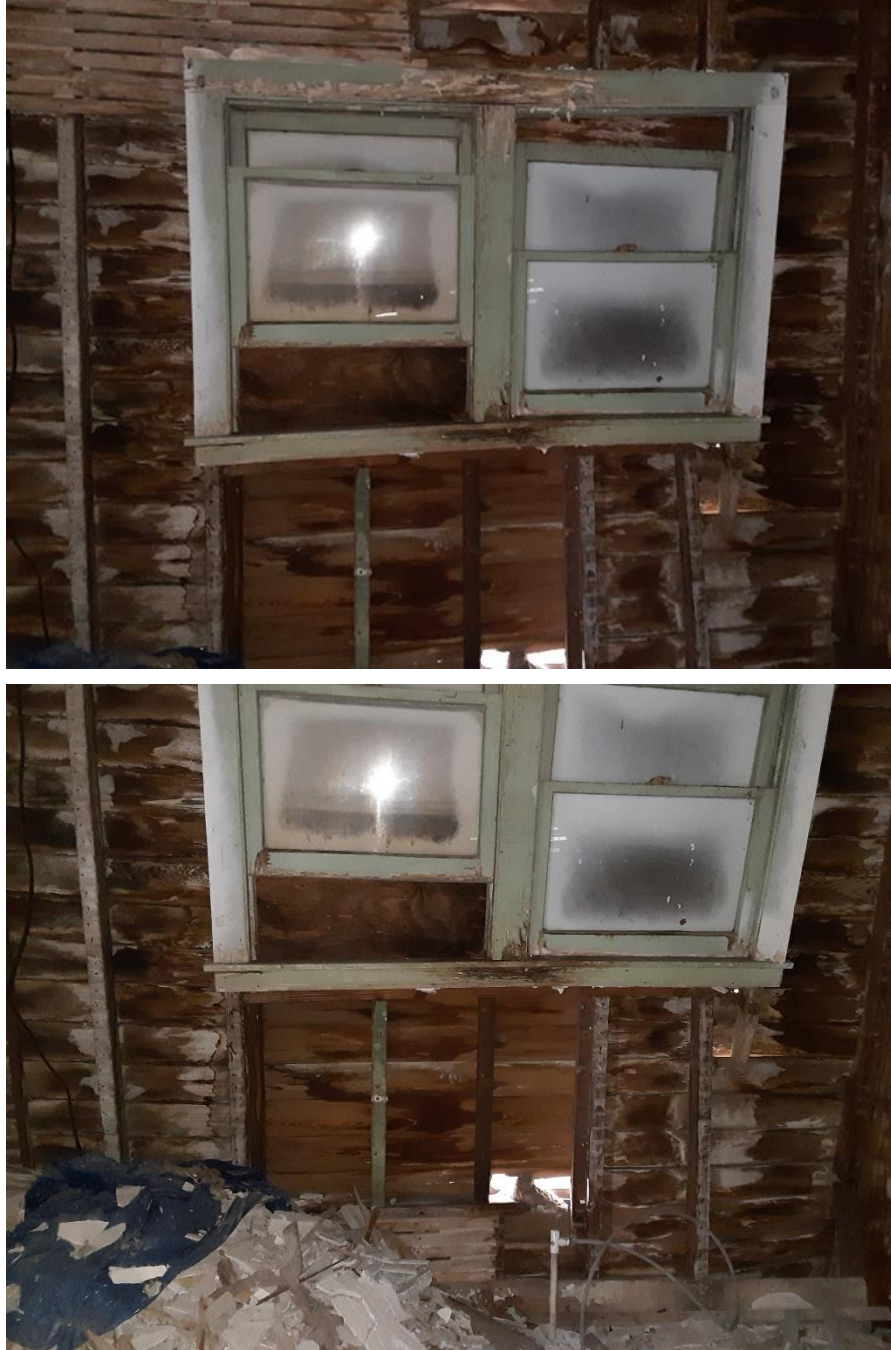
**Exterior Wall and Windows:** Some of the Studs, cripples and siding were damaged on the Right (West) exterior wall. In a limited section, the wall was bowing outward. In the photographs taken of this wall, all of the damage is not all visible.

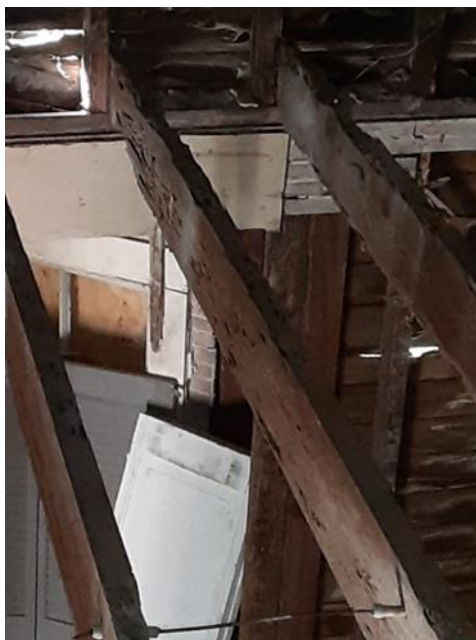
**Rotted/deteriorated ceiling/floor joist** (front (south) room area). Some of the joist had been removed.

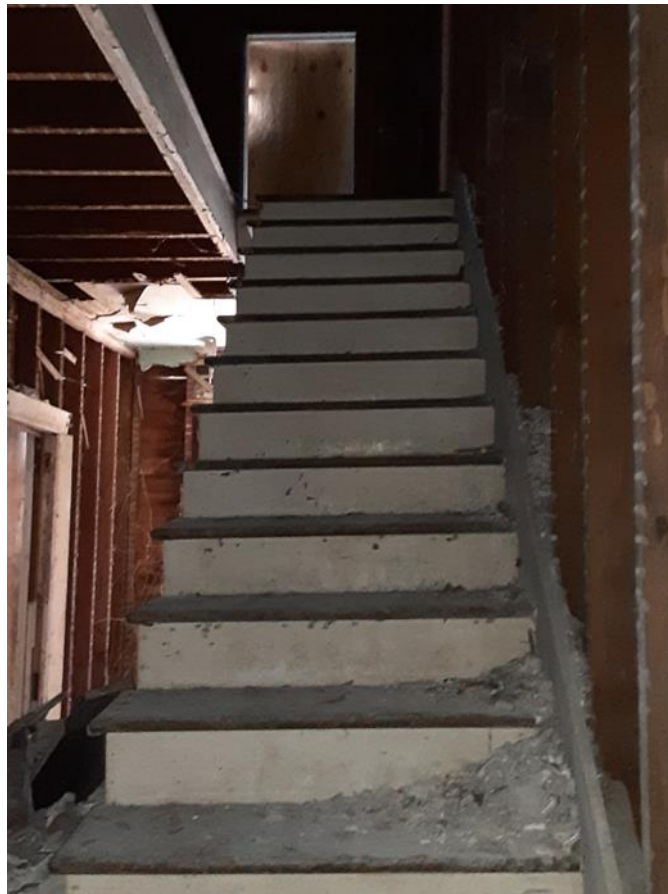
**Staircase:** Structural sound and fully Intact

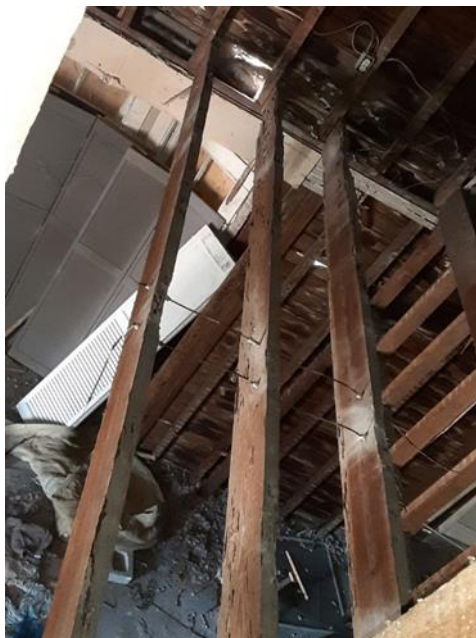
**Ceiling/Floor Joists Supporting Second Floor:** Deteriorated members; some missing.
